SECRET	
		25 X
	(c) NATIONAL PHOTOGRAPHIC INTERPRETATION CENTER	
	ge of Z-10436/84 Attachment to	8/84) PHIC
	ABM-RELATED CONSTRUCTIONMOSKVA, USSR	
		25 X
	SIGNIFICANCE: A CIRCULAR, FROEABLY CONCRETE, UNDERGROUND STRUCTURE IS OBSERVED AT MOSKVA ABM LAUNCH COMPLEX E05 THE STRUCTURE IS PROBABLY NOT AN ABM LAUNCH SILO. (SWN)	25X

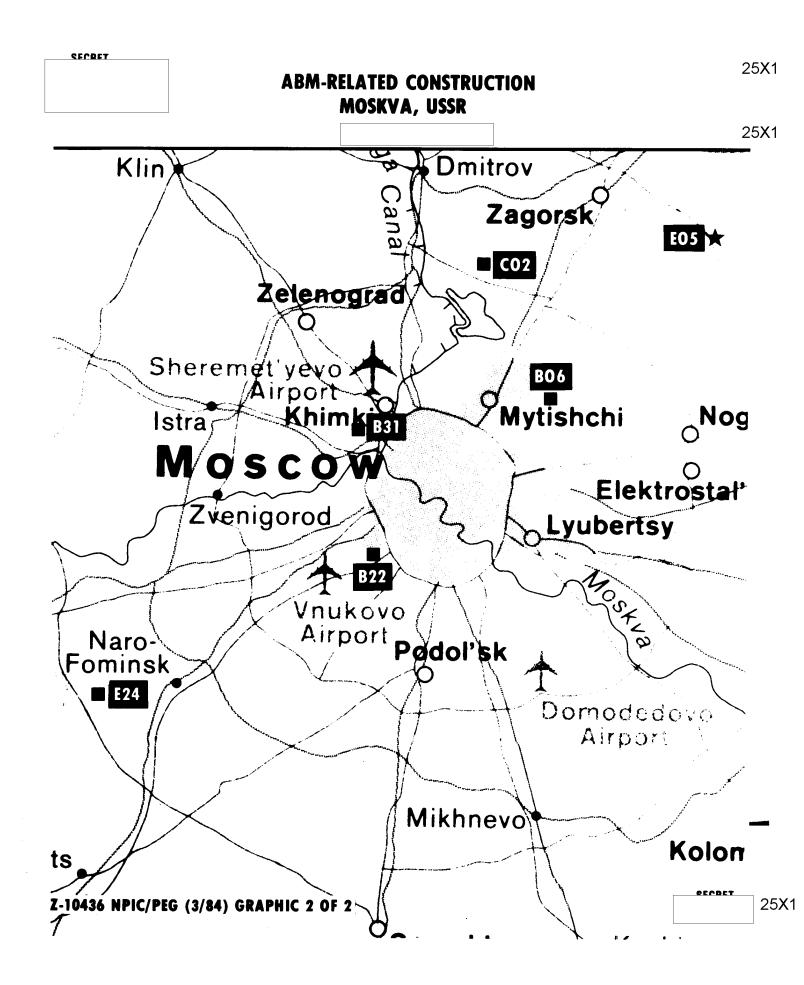
•	REMARKS:	25 X
	THE ABM SILOS THAT ARE UNDER CONSTRUCTION HAVE INNER DIAMETERS OF APPROXIMATELY 12 METERS AND OUTER DIAMETERS OF 13 METERS. THIS STRUCTURE IS SIMILAR TO THE ANOMALOUS SILO AT MOSKVA ABM LAUNCH SITE CO2	25X
	THE STRUCTURE IS NEXT TO ONE OF THE TRY ADD B RADAR BUILDINGS. IT IS NOT ALIGNED WITH THE ROW OF EIGHT ABM SILOS THAT ARE UNDER CONSTRUCTION OR WITH THE ROW OF EIGHT	25X
	ABOVEGROUND LAUNCHERS. CONSTRUCTION HAD PROBABLY REGUN THE PURPOSE OF THE STRUCTURE OR OF THE ANOMALOUS SILO HAS NOT BEEN DETERMINED. (SWN)	25X 25X
	ALTHOUGH SIMILAR STRUCTURES HAVE NOT BEEN SEEN AT THE OTHER ABM COMPLEXES, AN IRREGULARLY SHAPED EXCAVATION IS AT MOSKVA ABM LAUNCH SITE B31 AND TEMPLATES/RINGS HAVE BEEN IDENTIFIED AT MOSKVA ABM LAUNCH COMPLEX B06 AND	25X 25X
1	MOSKVA ABM LAUNCH COMPLEX E24 THESE TEMPLATES/FINGS (PROBABLY USED FOR INITIAL EXCAVATION) APPEAR TO BE IN TEMPORARY POSITIONS, AND NO EXCAVATIONS ARE OBSERVED. NO STRUCTURE, TEMPLATES/FINGS, OR EXCAVATIONS ARE SEEN AT	25X
